2012 NDIA GROUND VEHICLE SYSTEMS ENGINEERING AND TECHNOLOGY SYMPOSIUM

POWER AND MOBILITY (P&M) MINI-SYMPOSIUM AUGUST 14-16, MICHIGAN

POWERTRAIN EMBEDDED DIAGNOSTIC AND PREDICTIVE CAPABILITY FOR AN AUTOMOTIVE TRANSMISSION

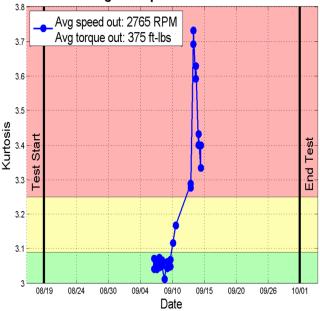
Figure 5: Transmission #1 kurtosis processing results

The results of the statistical analysis of the data collected during transmission #1 testing suggest that the transmission condition can be monitored by tracking the kurtosis of the vibration. Kurtosis was calculated for each data collection over every transmission operating test point group and the results indicate that this feature responds in a statistically significant manner to the developing damage, with sufficient damage sensitivity to provide in-situ detection capabilities. The processing results for transmission snapshots that were characterized by a 2,765 RPM output shaft speed and 375 ft-lbs output torque are illustrated in Figure 5.

In the illustration in Figure 5, it is evident that the steady state groups available for analysis from the transmission #1 testing are contained in a finite time window. No steady state data at this specific speed-load set point were recorded due to the inability of the transmission to support the commanded 2,765 RPM -375 ft-lbs set-point. The data in Figure 5 are therefore plotted on a more appropriate time scale in Figure 6 in order to more clearly capture the transition to failure that is indicated by the kurtosis feature.

Knowing that transmission #1's primary mode of failure was a loss of functionality in the 1st gear bearing on the 3rd range side, and hydraulic failure, it is likely that this observed rise in vibration kurtosis is correlated to the these failures. Long before testing completed it was reported that pieces of bearing cage were noticed in the oil sump. The measured rise in vibration kurtosis between September 10 and September 15 is likely a direct quantifiable indication of the failing bearing cage. As pieces of the degrading bearing cage were shed into the transmission, they caused mechanical interference with other moving components of the transmission, generating vibration and inducing secondary damage, until they were deposited in the oil sump. The wear debris generated from the bearing cage typically results in distributed damage across the entire bearing, including the rolling elements and raceways.

From the data presented in Figure 5 and Figure 6, it is obvious that the level of kurtosis computed from the vibration signal could be a useful tool for the predictive condition monitoring of the 1st gear bearing. The rising trend in kurtosis quantifies a degradation of the 1st gear right hand side bearing's functionality. As a result, the data presented in Figure 5 through Figure 8 are illustrated on a colored background reflecting three regions of assumed condition degradation. These regions of condition degradation are set by a kurtosis threshold. The green background signifies a fully functional 1st gear bearing, the yellow background reflects a degrading level of 1st gear bearing function, and the red signifies a critical 1st gear bearing.

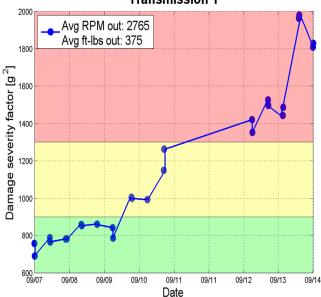
Figure 8: Transmission #1 DSF

To overcome this, Kurtosis was combined with variance to create a fused feature called the Damage Severity Factor (DSF). The DSF has been calculated for the steady state set points used in previous statistical analysis and is plotted in Figure 8. Data trends suggest that the amplitude of the DSF can be used to quantify the level of damage severity for transmission #1.

DSF thresholds were set to mark three levels of damage severity for transmission #1. These three levels of operational health are signified by the green, yellow, and red background colors in Figure 8. For the illustrations in Figure 5 through Figure 8 the background colors represent a fully functional 1st gear bearing, degrading 1st gear bearing, and a critical 1st gear bearing respectively.

of the onset of failure, due to its nature it tends to decline as the failure continues to get progressively worse. Therefore, it has been shown for this transmission that fusing another feature, in this case variance, provided a superior feature. Specifically this means that we want a feature that continues to rise as the fault severity continues to worsen. The fused feature which ARL called the Damage Severity Factor (DSF) in Figure 8 demonstrates this idealistic result.
